## Queen Street, Dunraven Place, Market Street Access Study April 2016

Bridgend County Borough Council (BCBC) have commissioned Capita to undertake a study to review methods and assess risks of increasing vehicular access to parts of Bridgend Town Centre.

The area under consideration commences at the southern end of Queen Street, continues along Dunraven Place and Market Street up to the junction with Quarella Road. These roads are to remain one-way north bound to the Cenotaph and then one way eastbound to its junction with Quarella Road.

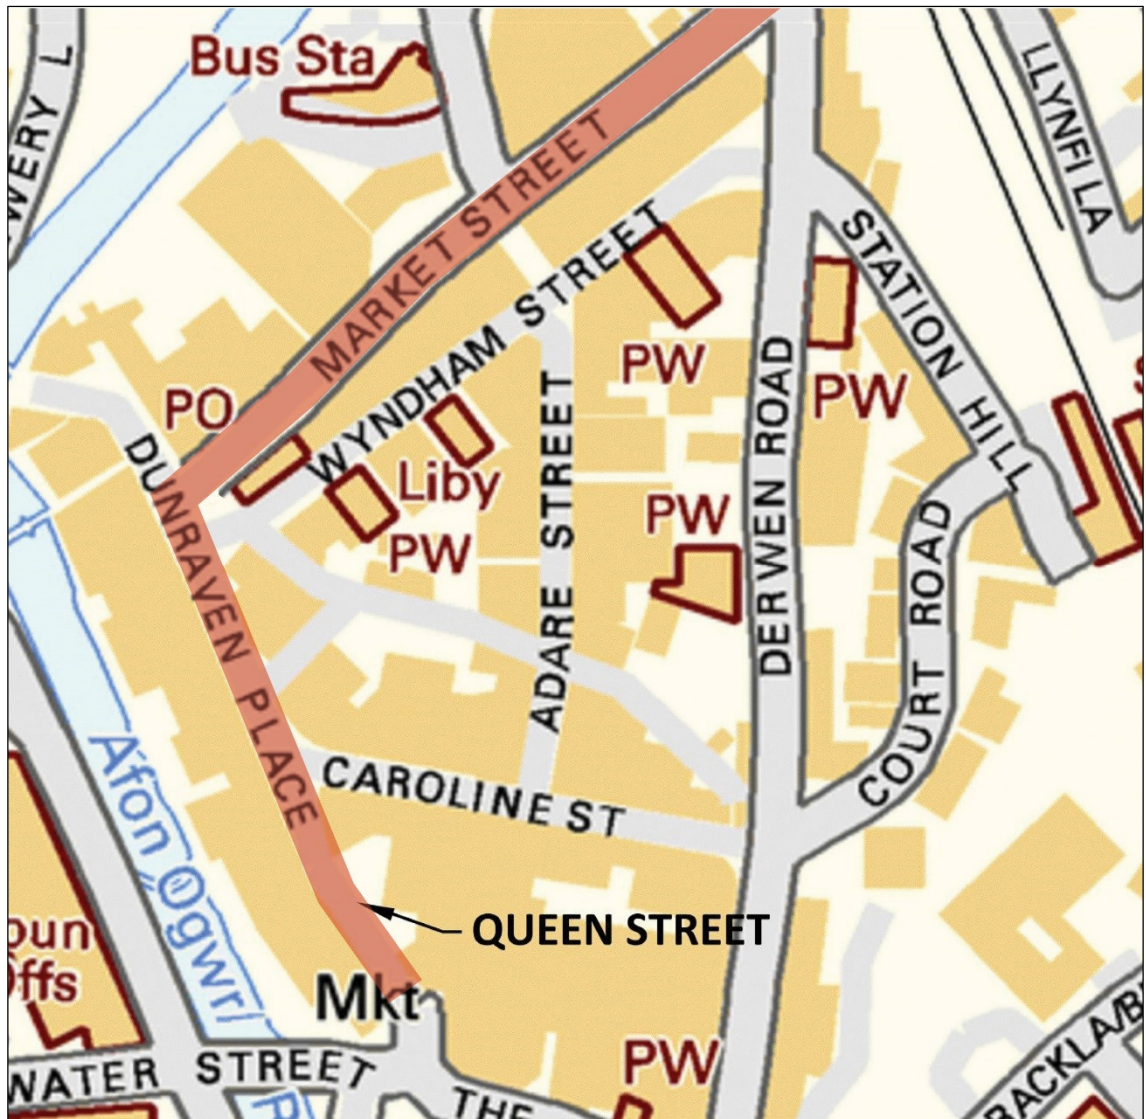
Figure 3.1 – Town Centre Street Map

The streets being considered in this study are:

- Queen Street from its junction with Water Street / The Rhiw;
- Dunraven Place;
- Market Street up to its junction with Quarella Road.

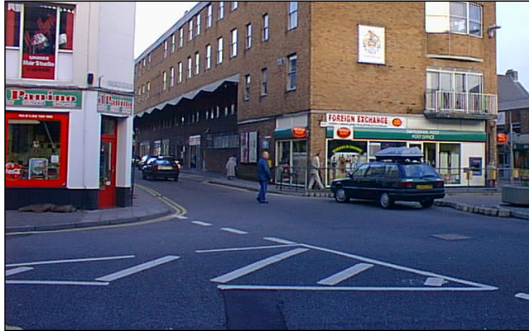
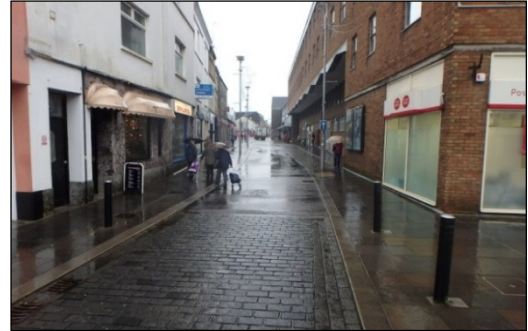
**Market Street**

Prior to pedestrianisation and the enhancement works, carriageways and footways were segregated by standard 100 / 125mm high kerbs. Roads and traffic were far more dominant, pedestrian facilities were of secondary importance with narrow footways made of a variety of materials ranging from small element concrete paving block to large concrete flag paving. In areas, pedestrians were contained to narrow footways by guardrail. A zebra crossing was provided at the Wyndham Arms to assist pedestrians to cross the road.

The appearance of the streets have been significantly improved by the pedestrianisation / enhancement works. The highway is now characterised by a narrow mainly tarmac carriageway typically measuring 3m to 3.5m wide. Footways are generally segregated from carriageways by

a wide silver grey conservation kerb with a flush to 0 to 20mm upstand. Footways utilise Caithness natural stone flags which have a riven finish.

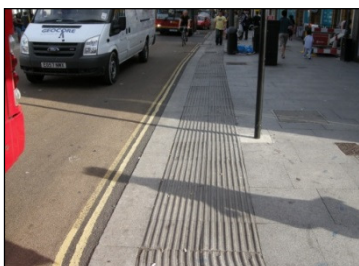
**Stone System**

- Concrete paving blocks. This is the most commonly used method, however the appearance of these would not be consistent with the high quality paving specification within the town centre;
- Stone units. A high quality finish could be provided by grinding the required finish into stone material to compliment other materials used in the town centre;
- Surface Mounted systems. These are basically adhesive tiles or bolt down strips.

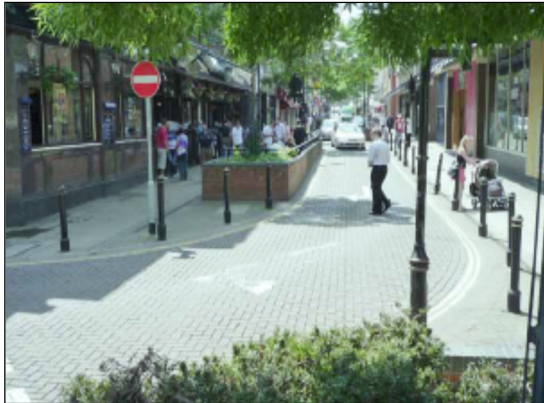
**Chertsey Road, Woking**

Design guidance recommends that bollards are set back at least 450mm from the edge of carriageway to minimise the risk of them being struck by passing vehicles. In addition, the selected bollard is likely to be approximately 100mm wide. In essence therefore, the effective footway width will be reduced by approximately 550mm and pedestrians will be channelled along narrower footways. Reducing the offset could be considered but this would increase the likelihood of them being struck by passing vehicles.

The following photos show typical street scenes where bollards have been used to prevent vehicles from accessing footways.

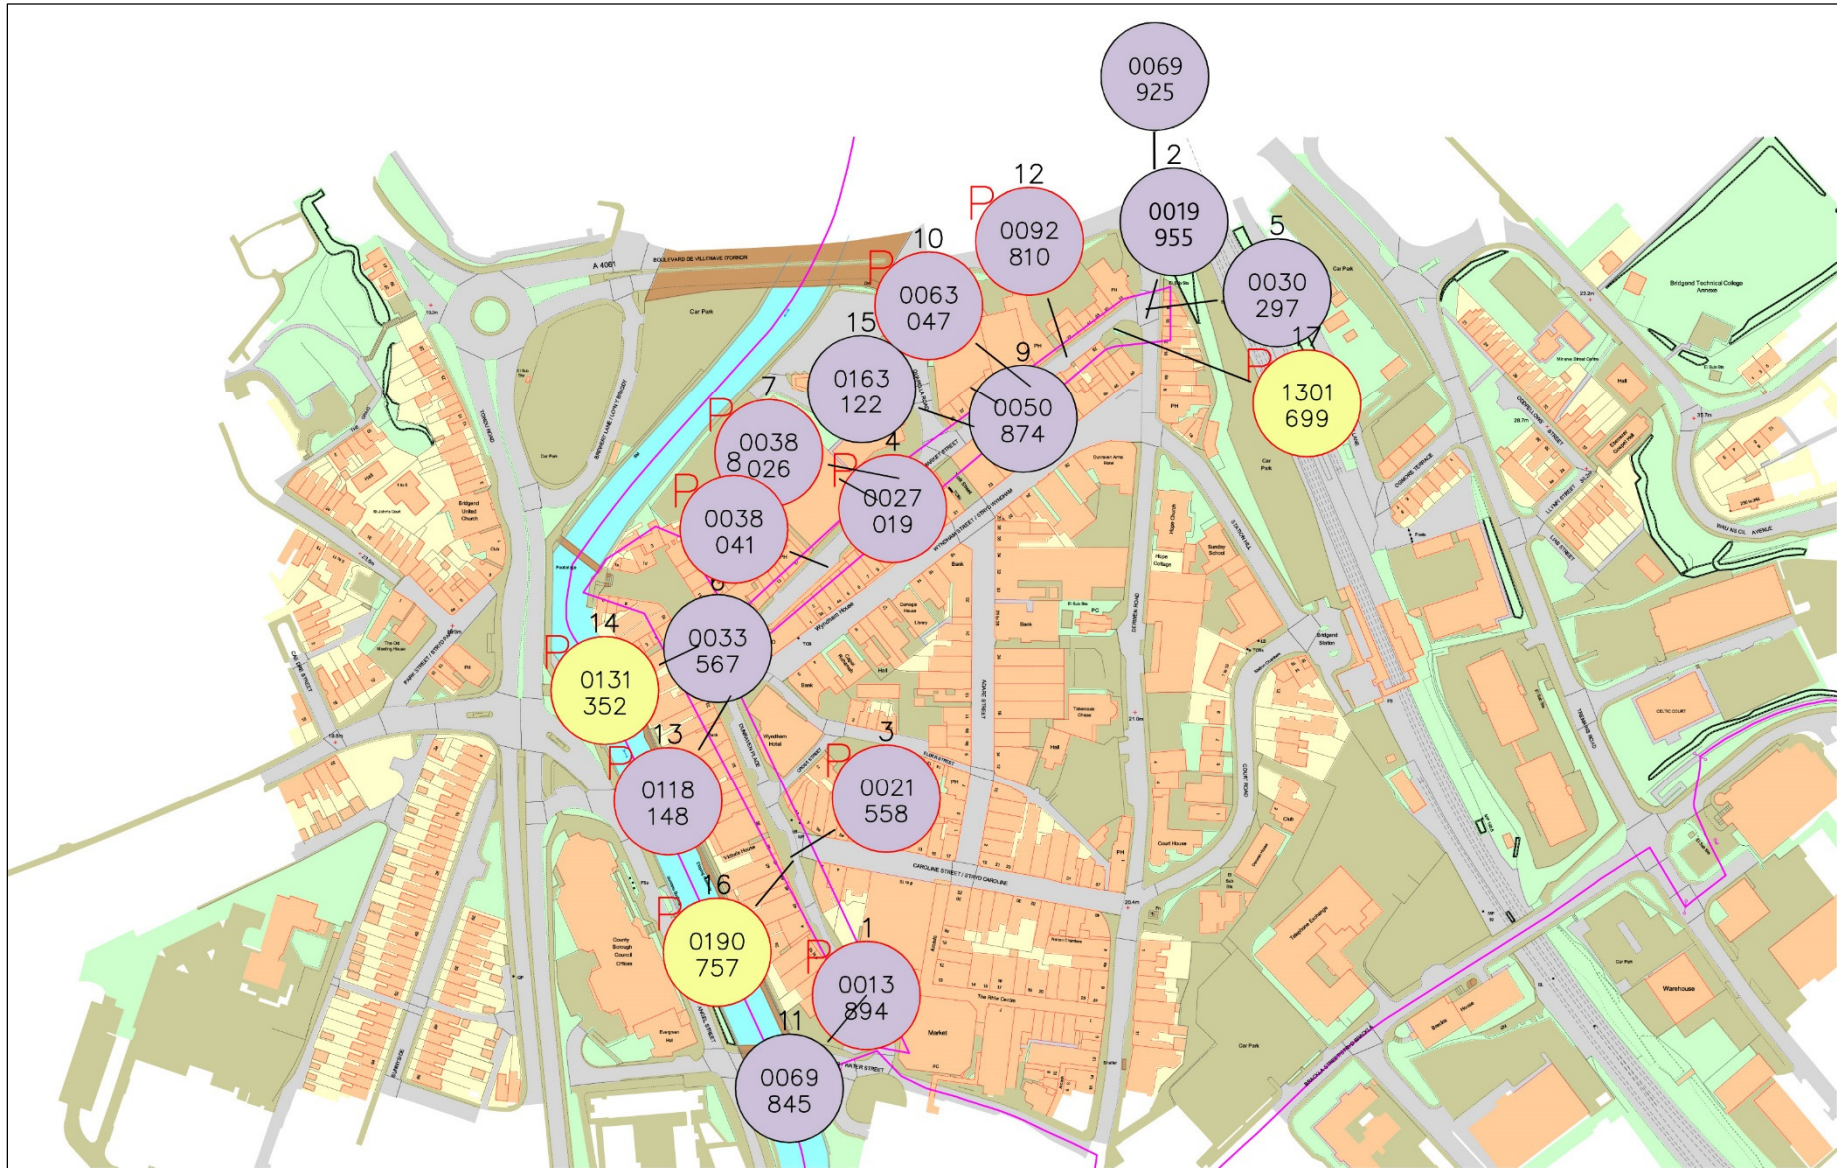
### Summary Table

Location	Number of collisions	Pedestrian Casualties	Severity
Collisions on route pre-pedestrianisation	13	8	Slight
Collisions on route post-pedestrianisation	3	3	Slight
Collisions Nolton Street	1	0	Slight

Refer to Appendix A – Collision Data Plan and Details for locations of Collisions.

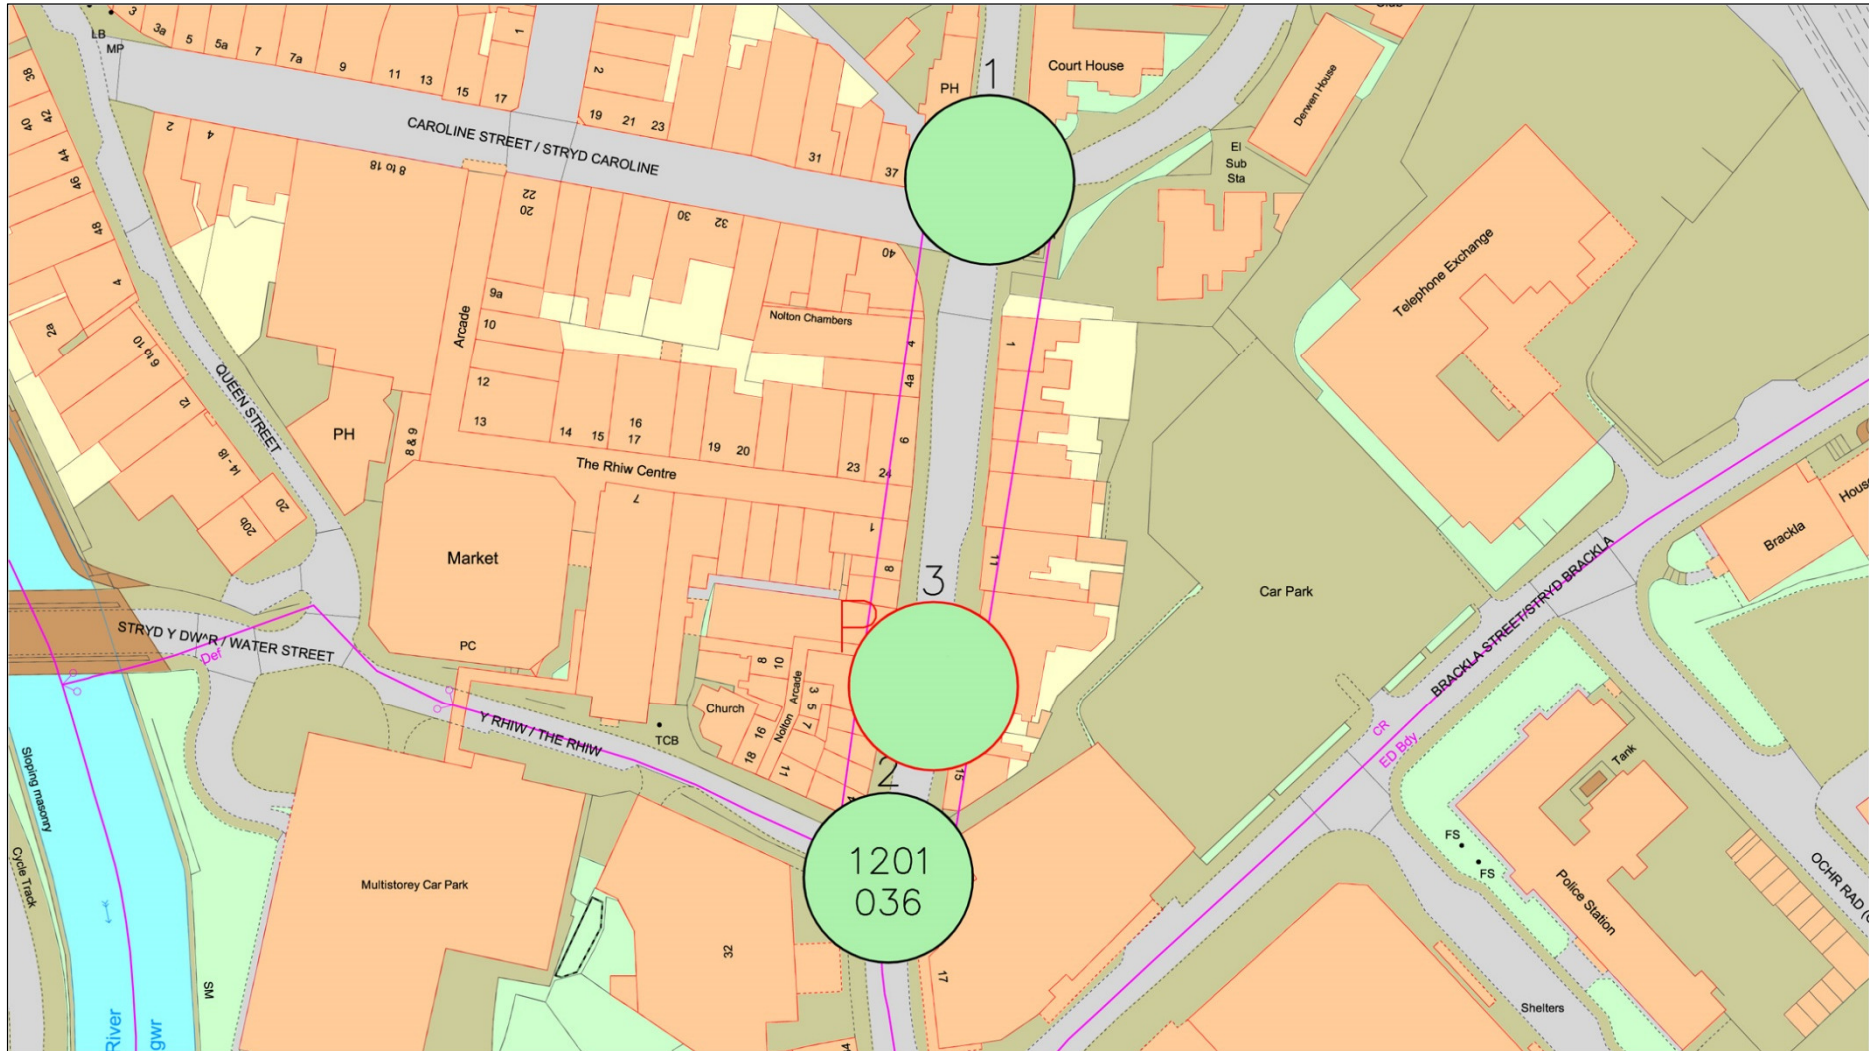
Norton Street Between Court Road to Brackla Street Junctions (January 2010 to December 2014)

Nolton Street Between Court Road and Brackla Street Junctions (January 2000 – December 2014)
